**Oconee County
REAL ESTATE, FACILITIES &
LAND MANAGEMENT MEETING
AGENDA**

Re: Hazardous Materials Survey Report
Former Fair Play Cafeteria
150 School Road
Fair Play, South Carolina
Terracon Project No. 86187019

Hazardous Materials Survey Report

Terracon Project No. 86187019

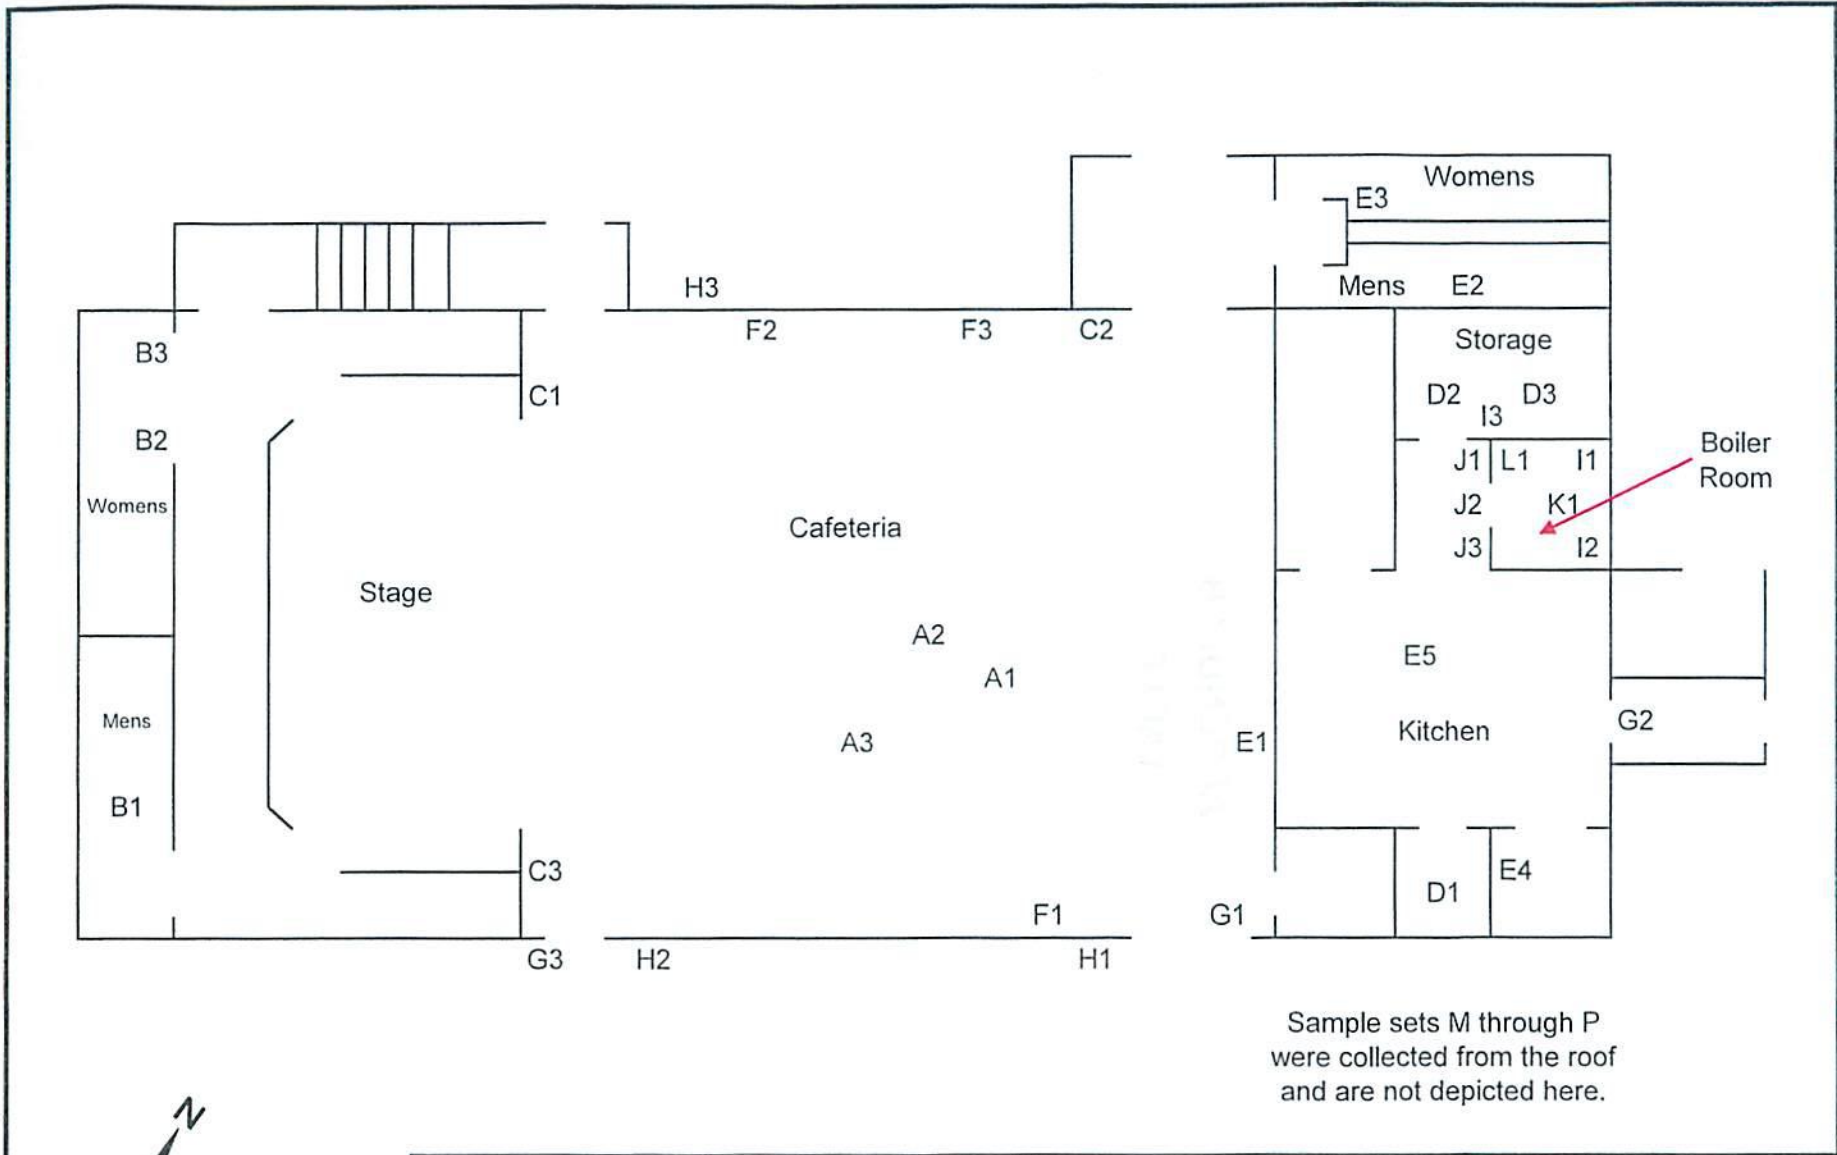
APPENDIX A
FIGURES

Sample sets M through P were collected from the roof and are not depicted here.

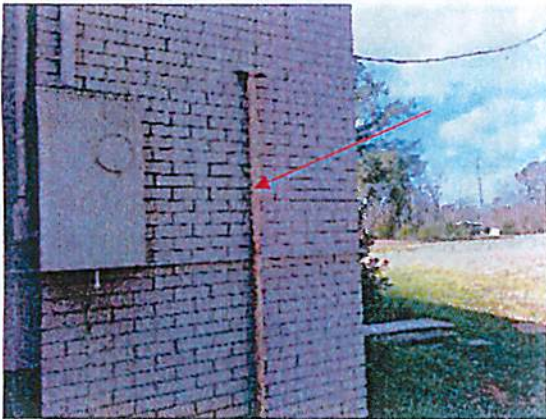
- One heating/fuel oil underground storage tank (UST) to feed the old boiler;
- Potential multiple gas/diesel USTs were observed in regards to the former gas pumps at the north boundary of the site;
- One container of miscellaneous cleaner (one gallon or less);
- Twenty-two 1-gallon cans of paint (undetermined if lead based, latex or acrylic);
- Four 5-gallon buckets of paint (undetermined if lead based, latex or acrylic);
- Eight aerosol cans of paint or chemicals; and,
- One compressed gas cylinder of liquid propane.

Photo #13 View of a heating/fuel oil tank vent on the exterior of the boiler room.

Terracon recommends that the above chemicals and cleaners be lab packed and disposed of at an appropriate facility. The USTs require specialized pumping, removal, and closure with a certified contractor prior their disposal or recycling.

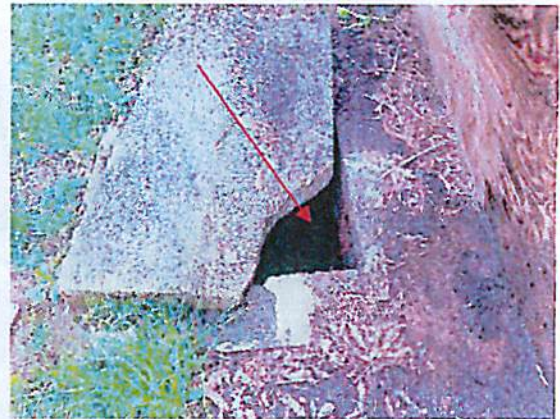
- One heating/fuel oil underground storage tank (UST) to feed the old boiler;
- One septic tank or waste food grease tank;
- Potential multiple gas/diesel USTs were observed in regards to the former gas pumps at the north boundary of the site;
- One container of miscellaneous cleaner (one gallon or less);
- Twenty-two 1-gallon cans of paint (undetermined if lead based, latex or acrylic);
- Four 5-gallon buckets of paint (undetermined if lead based, latex or acrylic);
- Eight aerosol cans of paint or chemicals; and,
- One compressed gas cylinder of liquid propane.

Photo #14 View of grease or septic tank located at the northern corner of the building.

Terracon recommends that the above chemicals and cleaners be lab packed and disposed of at an appropriate facility. The USTs require specialized pumping, removal, and closure with a certified contractor prior their disposal or recycling.

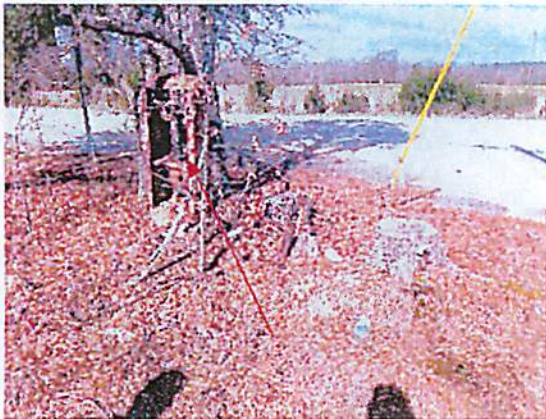
Photo #15 View of an old gas pump body located at the edge of the property adjacent to the ambulance garage.

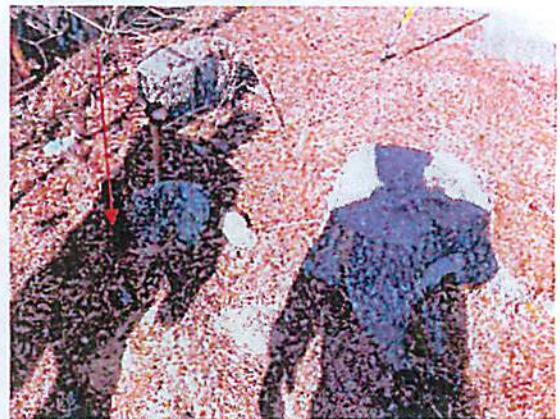
Photo #16 View of an old gas tank vents located at the edge of the property adjacent to the ambulance garage.

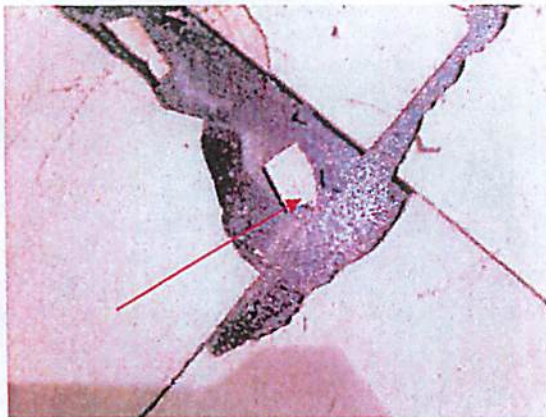
Photo #17 View of 12" crème floor tile and black mastic (HA-A) in the main area of the cafeteria.

Materials containing greater than 1% asbestos must be removed by an SC DHEC-licensed abatement contractor prior to disturbance from renovation or demolition actions. Materials that are damaged should be repaired or abated prior to renovations. Third party asbestos air monitoring must be performed during prior to, during, and at the conclusion of the abatement of the regulated materials.

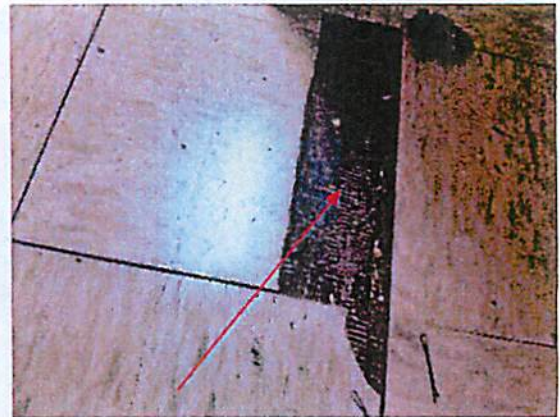
Photo #18 View of 12" gray streaked floor tile and black mastic (HA-B) in the rear stage restrooms

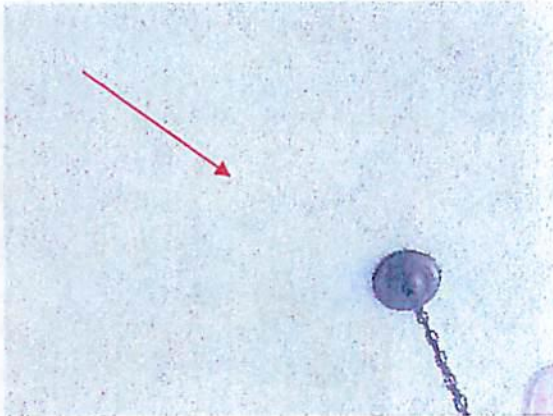
Photo #19 View of ceiling texture (HA-D) in various areas of the building.

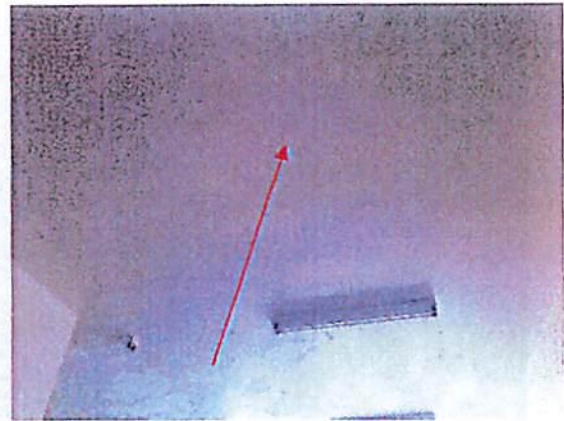
Photo #20 View of plaster ceiling skim coat (HA-E) in various areas of the building.

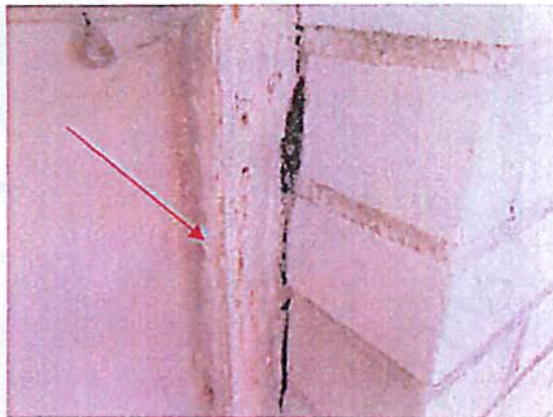
Photo #21 View of window glazing compound (HA-F) on windows throughout the building.

Materials containing less than 1% asbestos, while not regulated by the EPA or SC DHEC, are regulated by OSHA. As such, workers handling or disposing of such materials should be properly trained to identify and acknowledge the potential hazards. Since many contractors do not have such training, Terracon recommends that these materials should also be removed by a licensed abatement contractor.

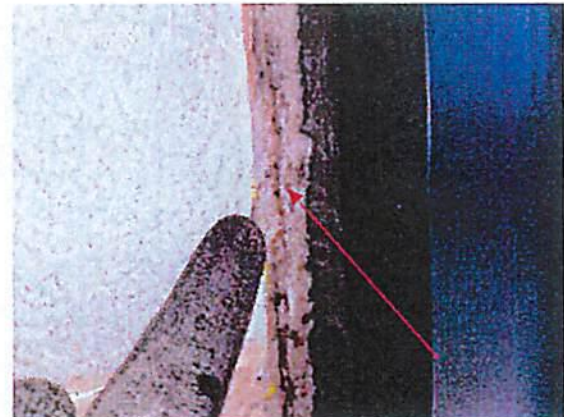
Photo #22 View of door caulking (HA-G) on doors throughout.

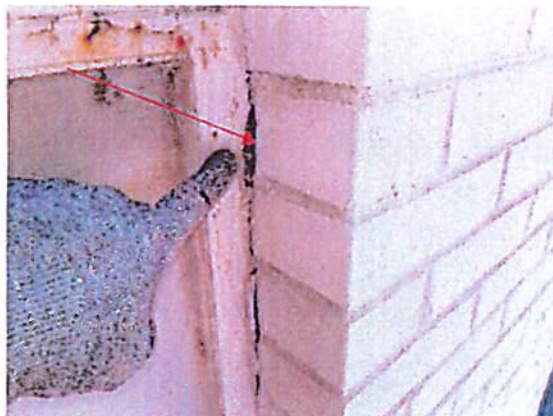
Photo #23 View of exterior door caulking (HA-H) on exterior windows throughout.

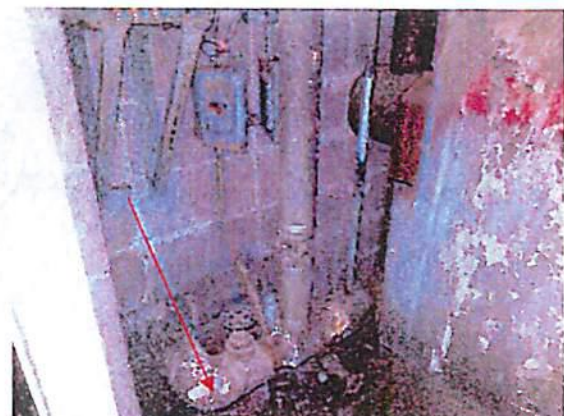
Photo #24 View of hard joints (HA-J) on boiler piping throughout the building.

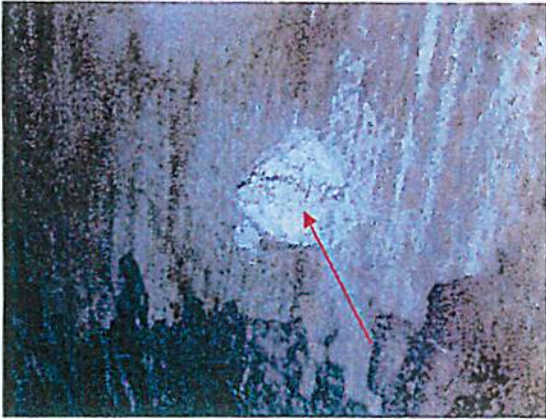
Photo #25 View of boiler body insulation (HA-K) on the boiler.

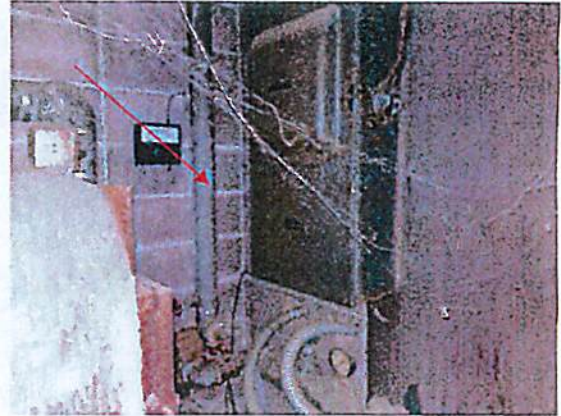
Photo #26 View of hard pipe insulation (HA-L) on the boiler piping throughout the building.

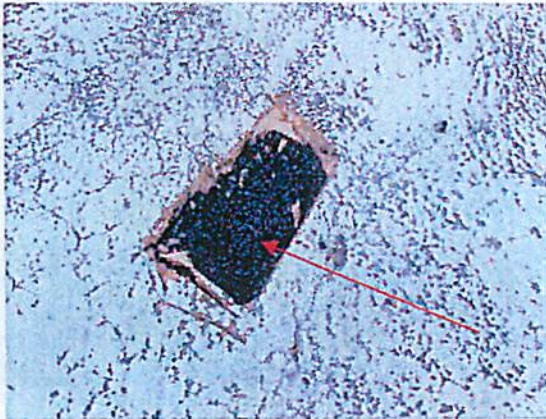
Photo #27 View of built-up roofing (HA-M) under spray foam on the roof.

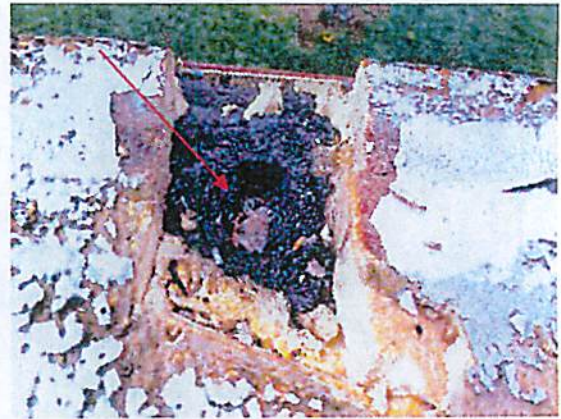
Photo #28 View of edge/penetration flashing (HA-N) under spray foam on the roof.

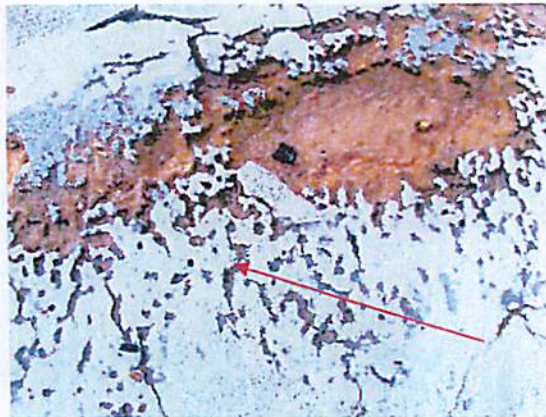
Photo #29 View of white mastic (HA-O) on spray foam on the roof.
